NATIONAL TRANSPORTATION SAFETY BOARD
Investigative Hearing

Amtrak Passenger Train 501 Derailment
DuPont, Washington
December 18, 2017

RRD18MR001

Crashworthiness and Survival Factors

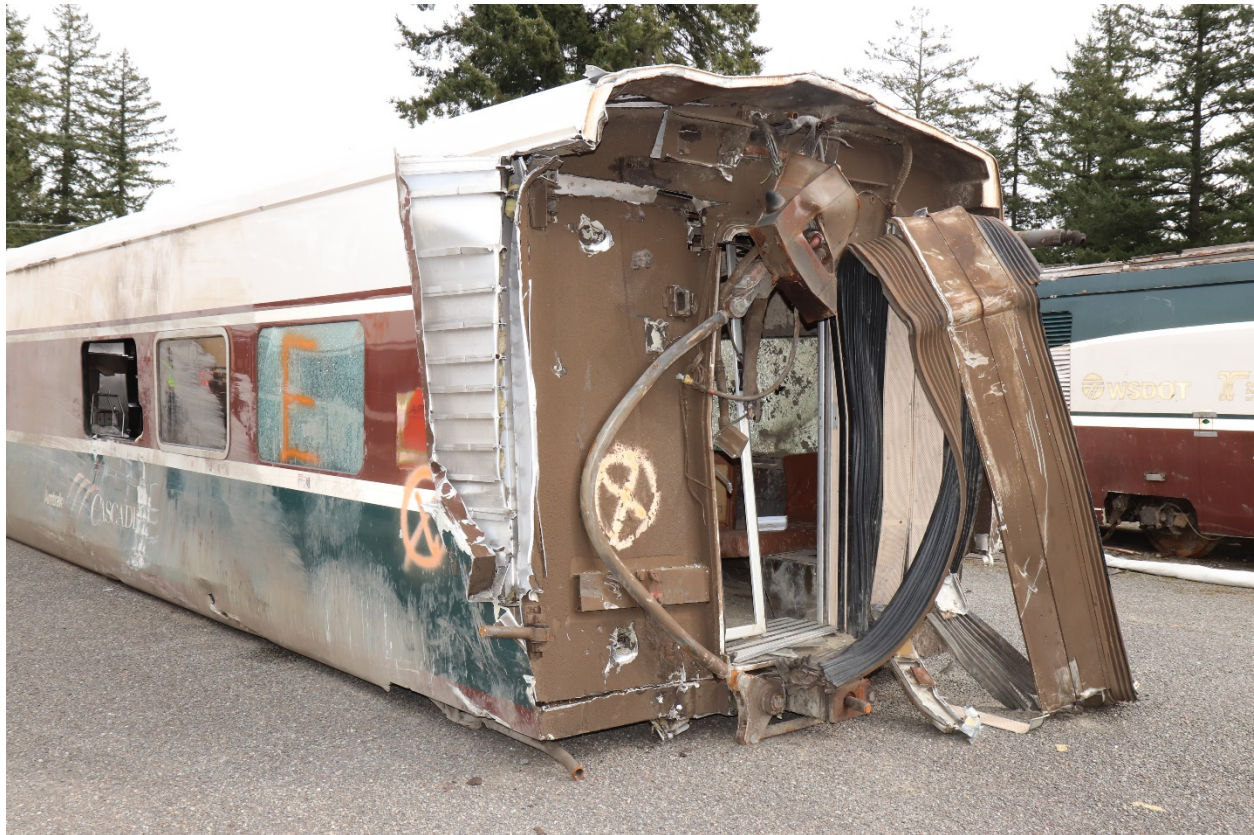
the left side floor-line. The left side weight bearer bar was severely deformed and bent, unmounted from its mating car; AMTK 7504. The right-side bearer bar was fractured at the base. The lower guidance bars both exhibited indications of overstress and failed during the derailment. The left and right side lower straps were broken, and the articulated coupler was fractured during the derailment.

Figure 34. AMTK 7303 Suspended end and left side.

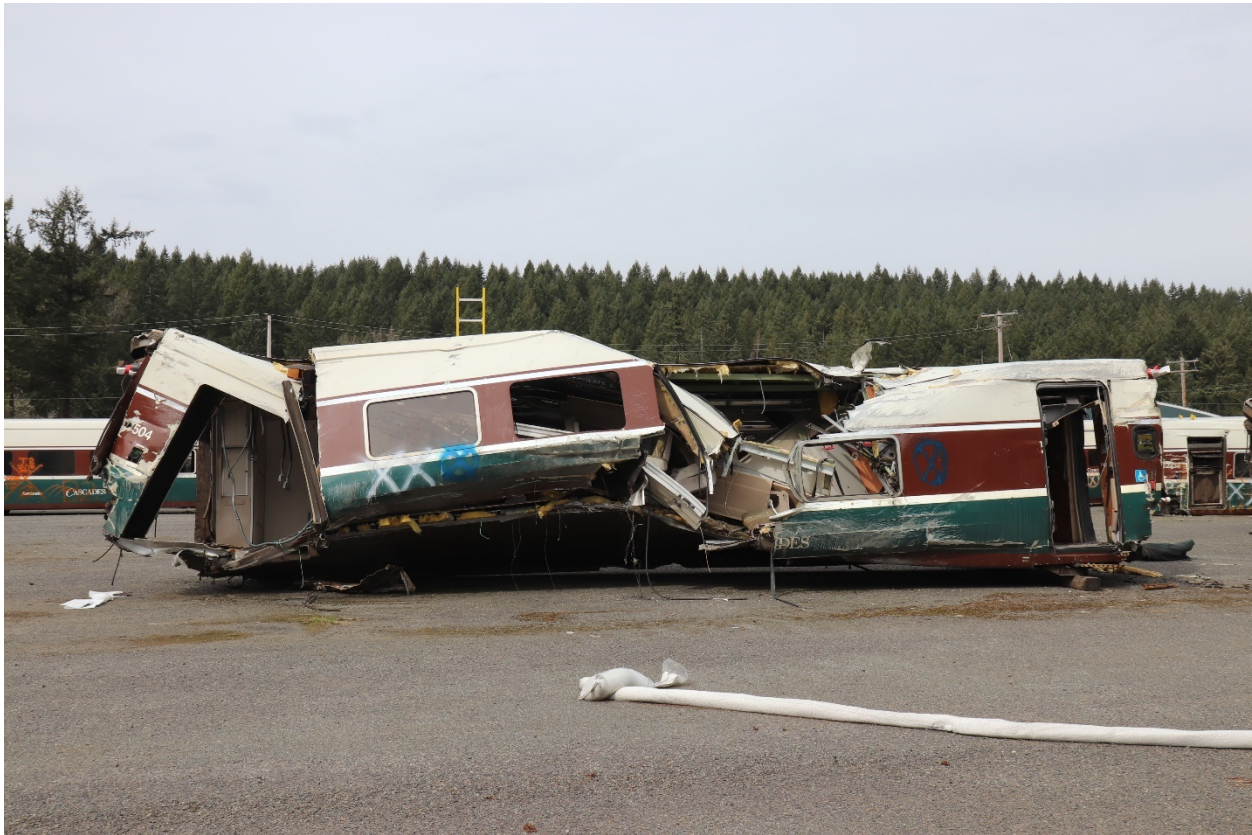
compartment against occupied areas within the car. Investigators determined the rolling assembly was from car AMTK 7422.

Figure 35. AMTK 7504 Left side.

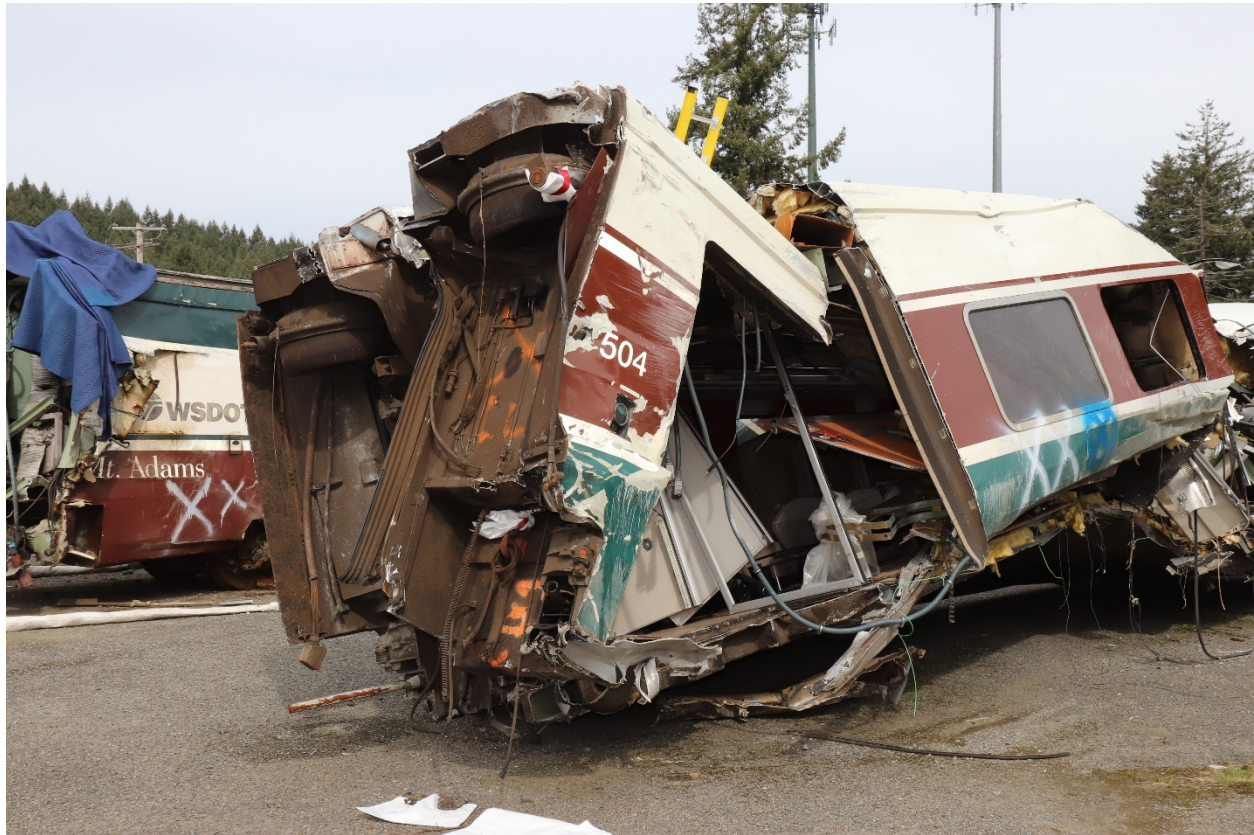
articulated connection [between AMTK 7303] was twisted and fractured. All rolling assembly attachments [guidance bars] were broken. The rolling assembly of AMTK 7504 detached during the derailment.

Figure 36. AMTK 7504 Supported end and left side.

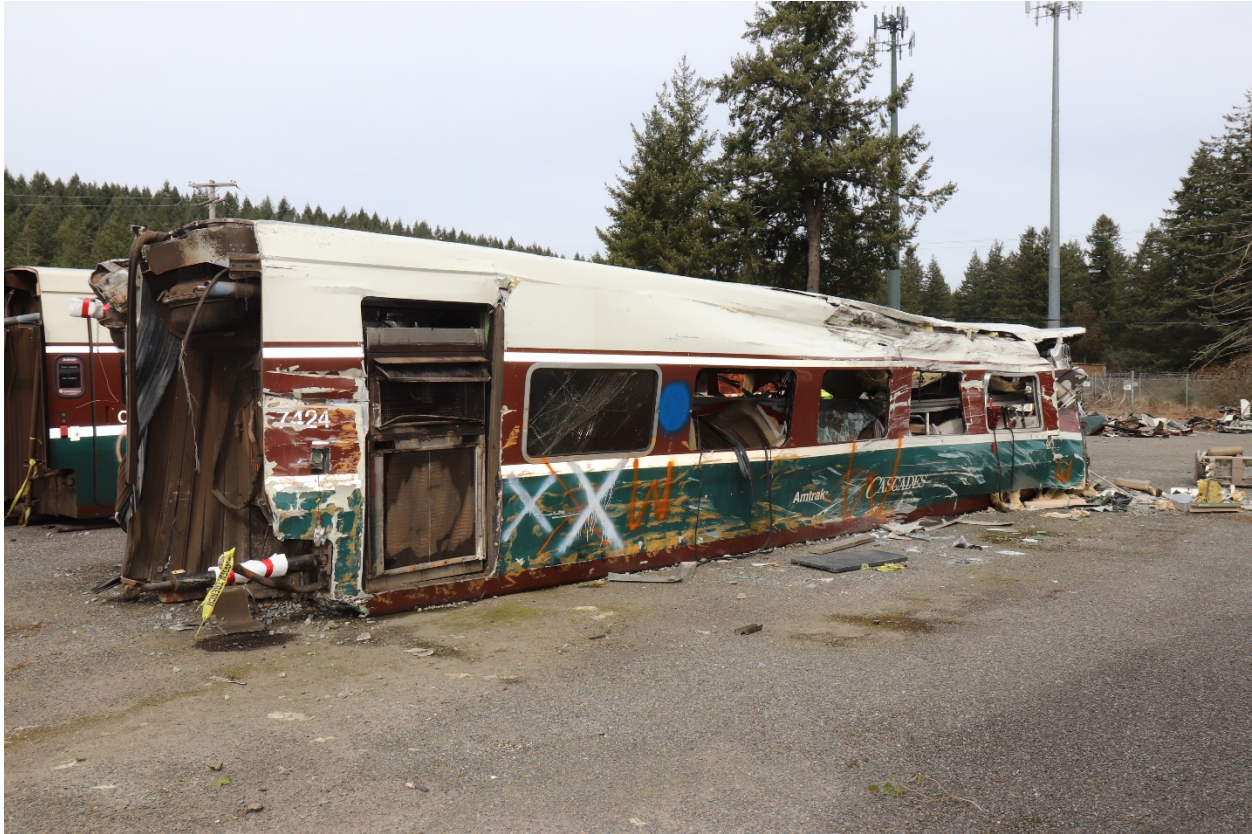
The left side wall of AMTK 7424 was heavily scraped and abraded but remained intact. The structure was slightly pushed inward from the suspended end to the approximate center of the car. The roof line from the suspended to the approximate center of the car end was fractured and slightly pushed inward. Four of five windows were missing.

Figure 38. AMTK 7424 Left side.

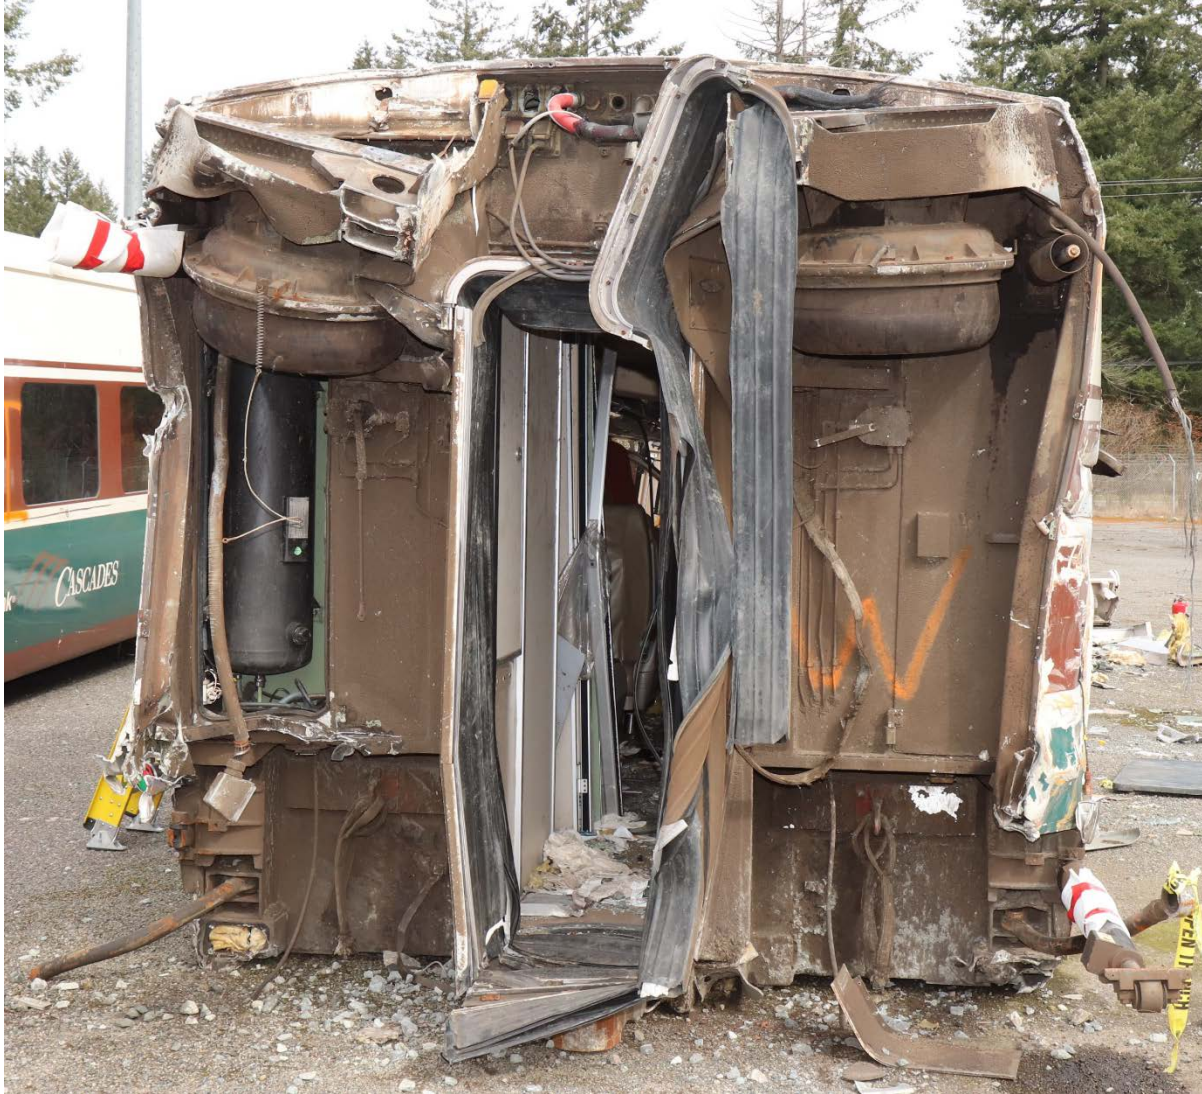
The supported end of AMTK 7424 exhibited indications of car to car engagement. The right-side tower support structure was deformed, deflected downward and partially separated from the end wall. Both air springs were in place during this examination. The weight bearer connections failed. The articulated connection [between AMTK 7424] was fractured during the derailment. All rolling assembly attachments [guidance bars] were broken. The rolling assembly of AMTK 7424 detached during the derailment and rolled across Interstate 5.

Figure 39. AMTK 7424 supported end.

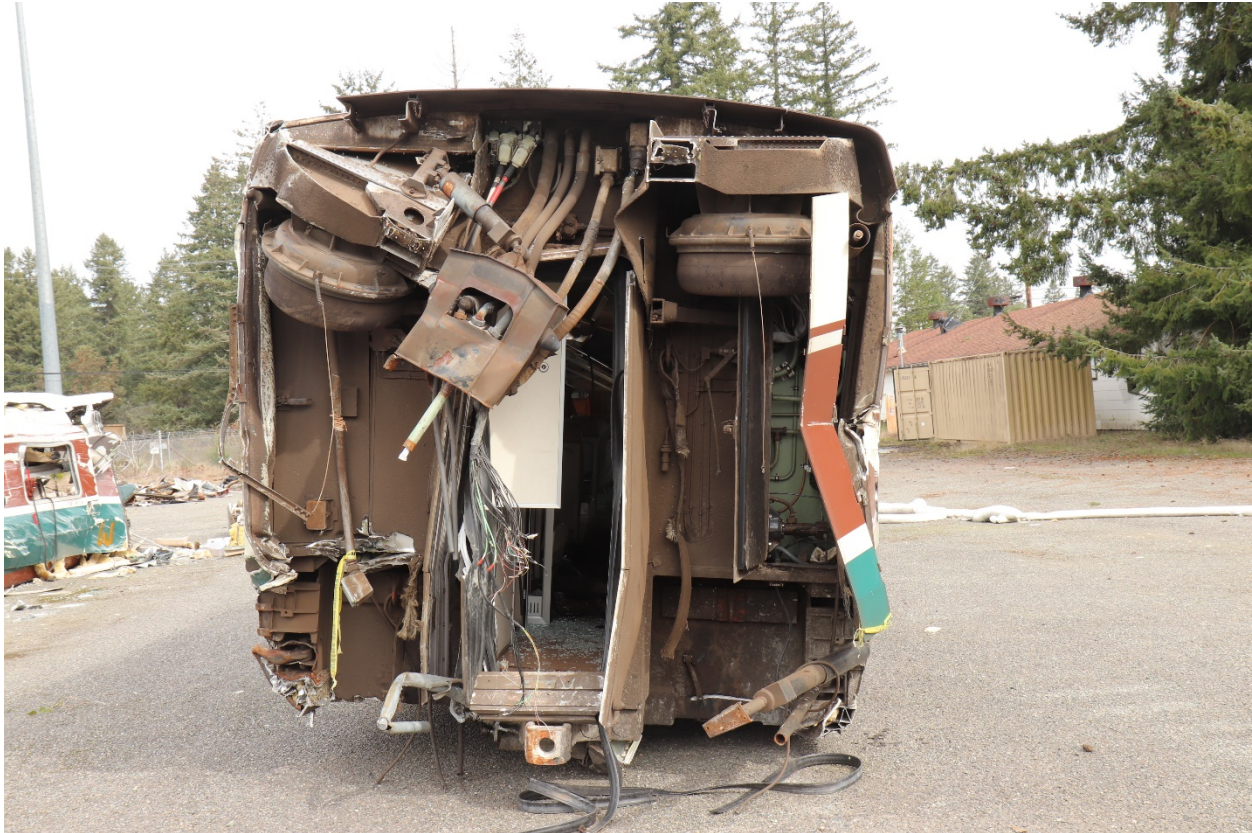
Bridge railing structure is evident in figure 45 at the lower left adjacent to the articulated coupler.

Figure 45. AMTK 7421 Supported end.

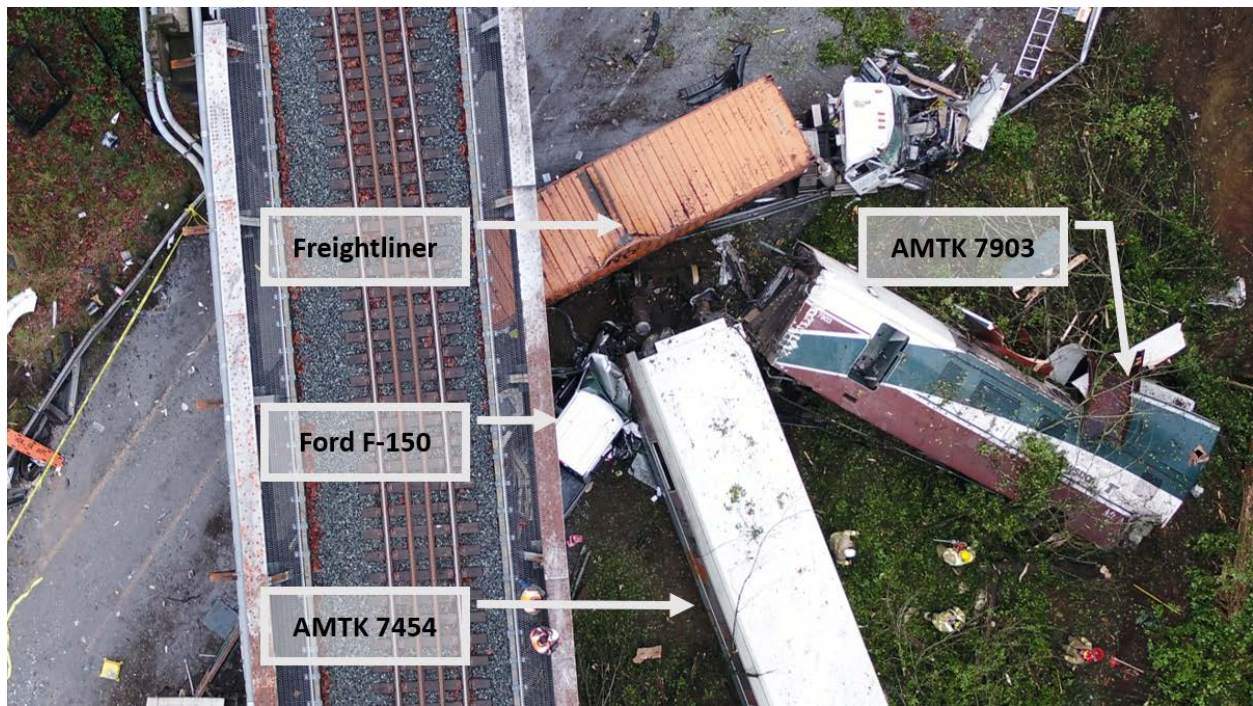
Figure 51. Final resting position of Ford F150 and Freightliner. (Photo WSP)

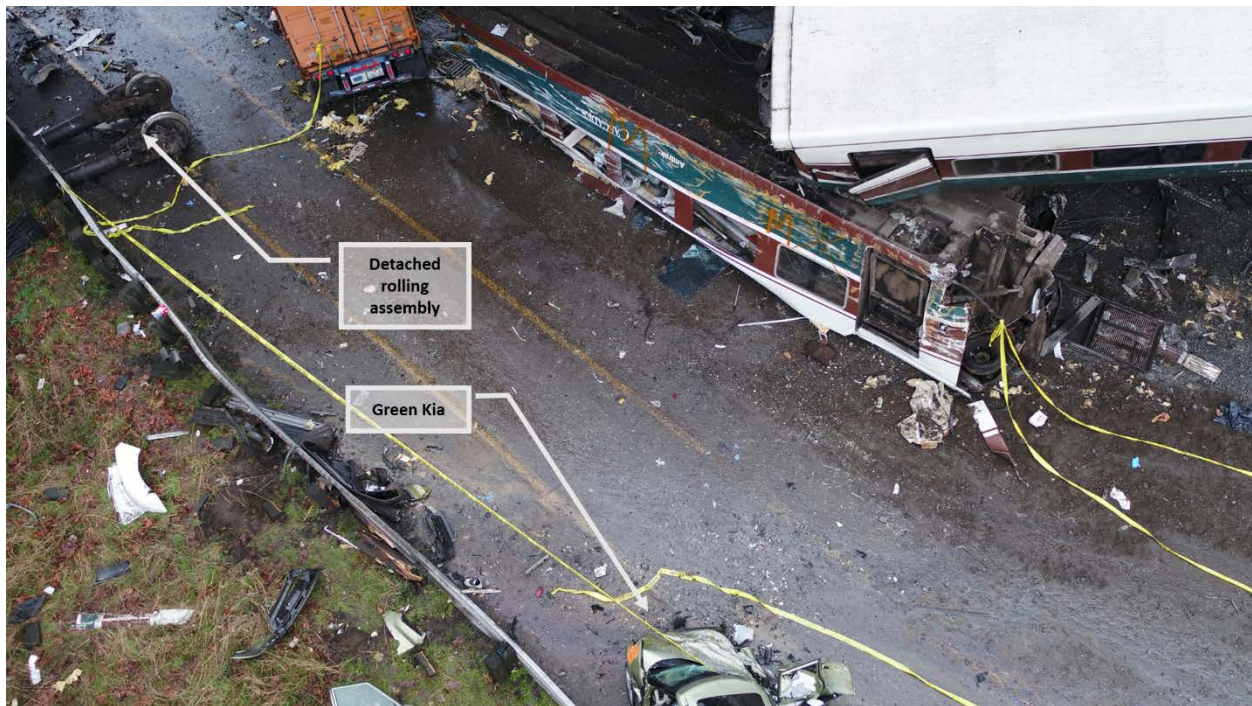
Figure 52. Green Kia and rolling assembly on Interstate 5. (Photo WSP)

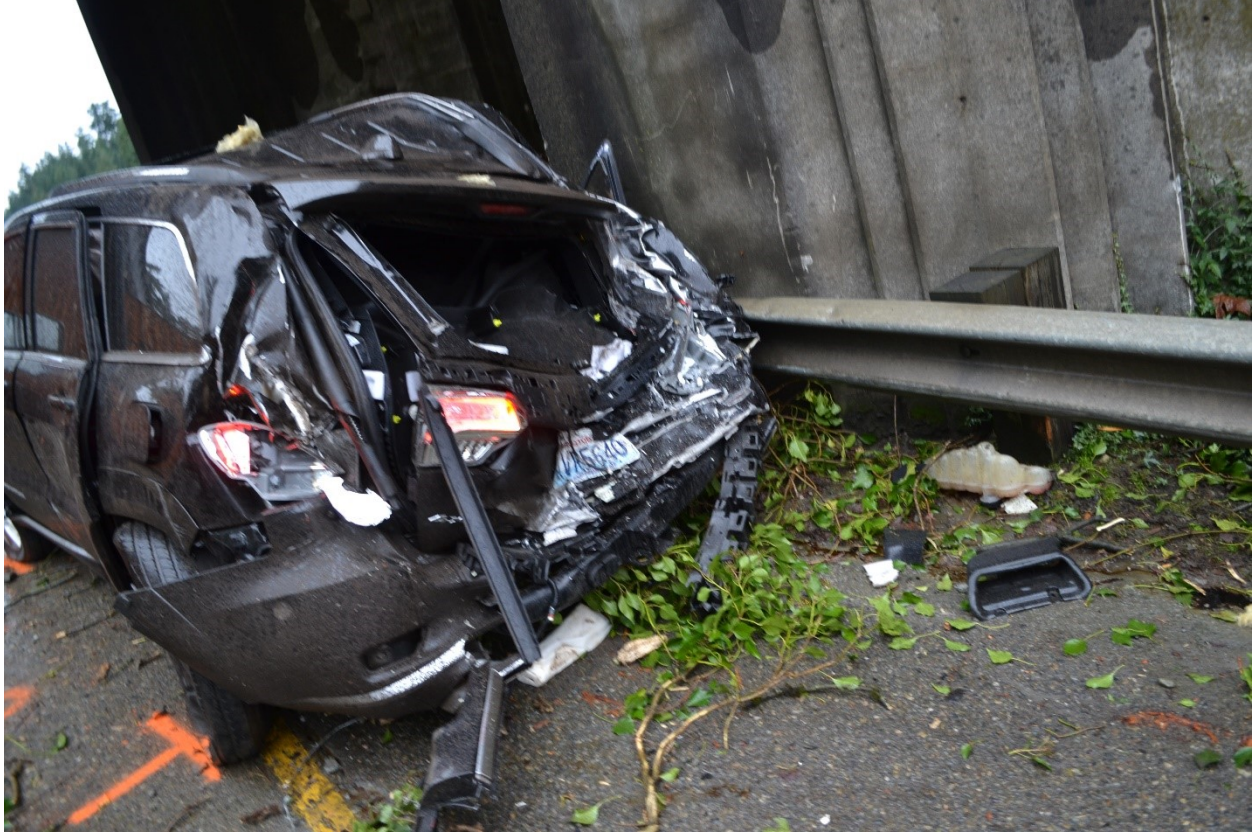
Figure 53. Damaged Jeep Grand Cherokee.

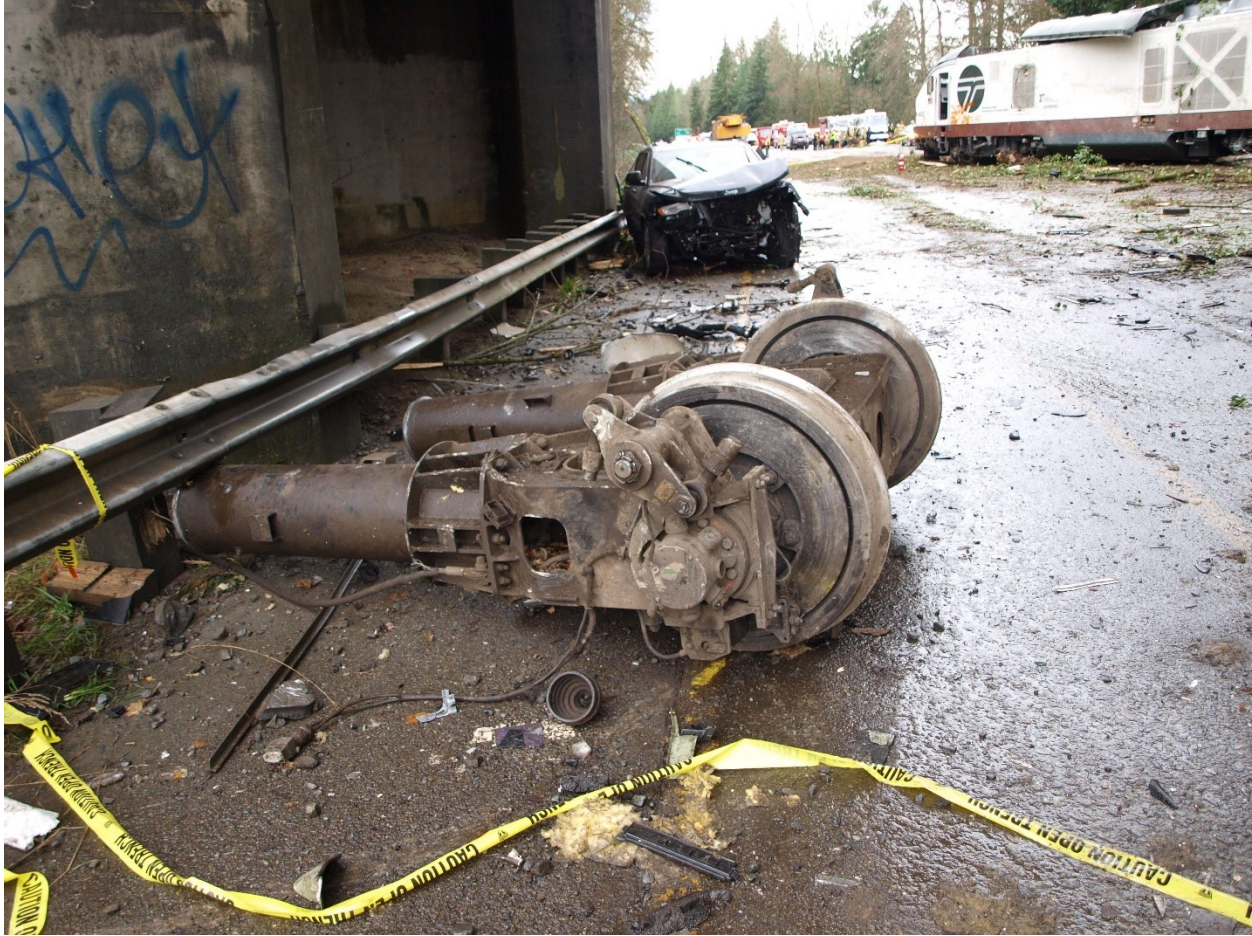
Figure 54. Detached rolling assembly and Jeep Grand Cherokee. (Photo WSP)

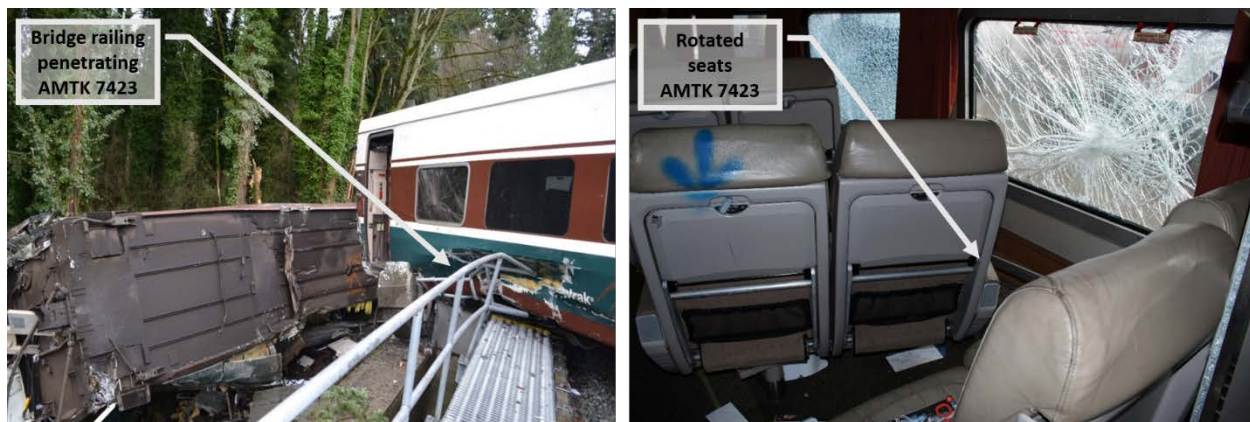
Figure 59. Bridge railing penetrating AMTK 7423 and displaced passenger seats.

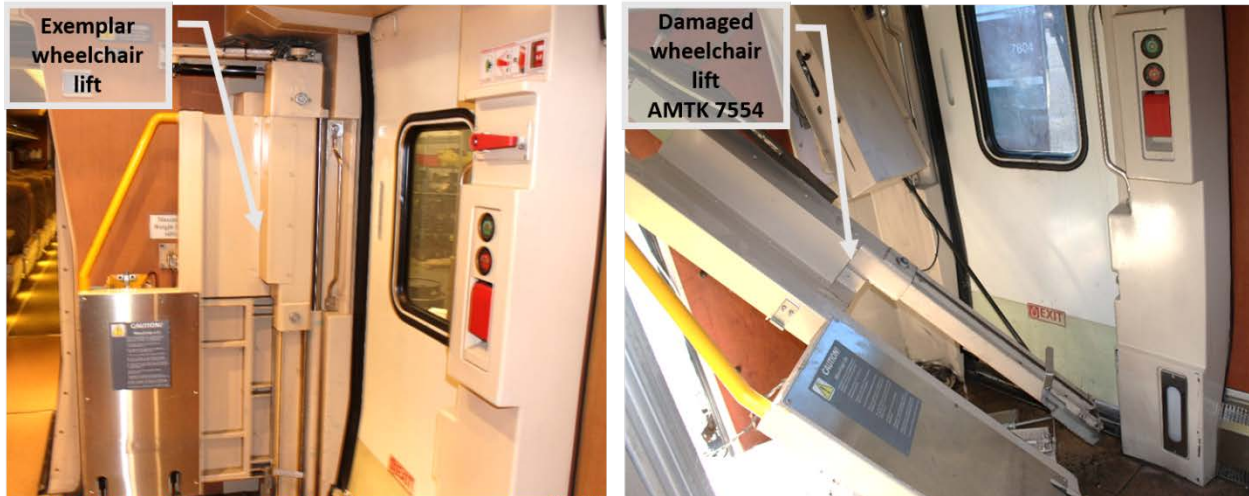
Figure 60. Exemplar wheelchair lift and damaged lift in AMTK 7554.

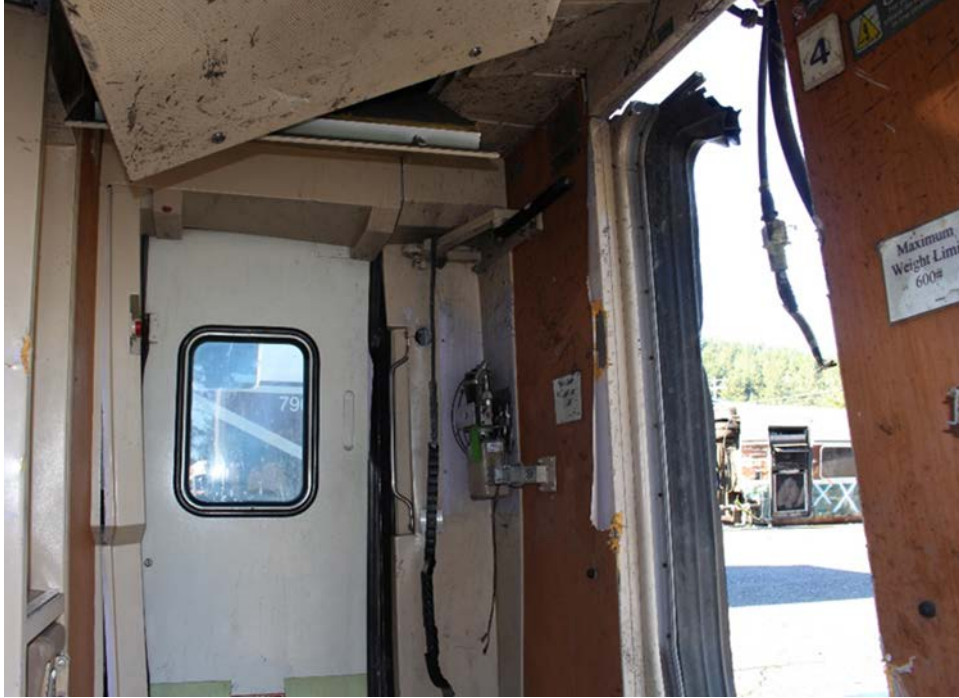
Figure 61. Photograph of missing wheelchair lift and damage to AMTK 7504.

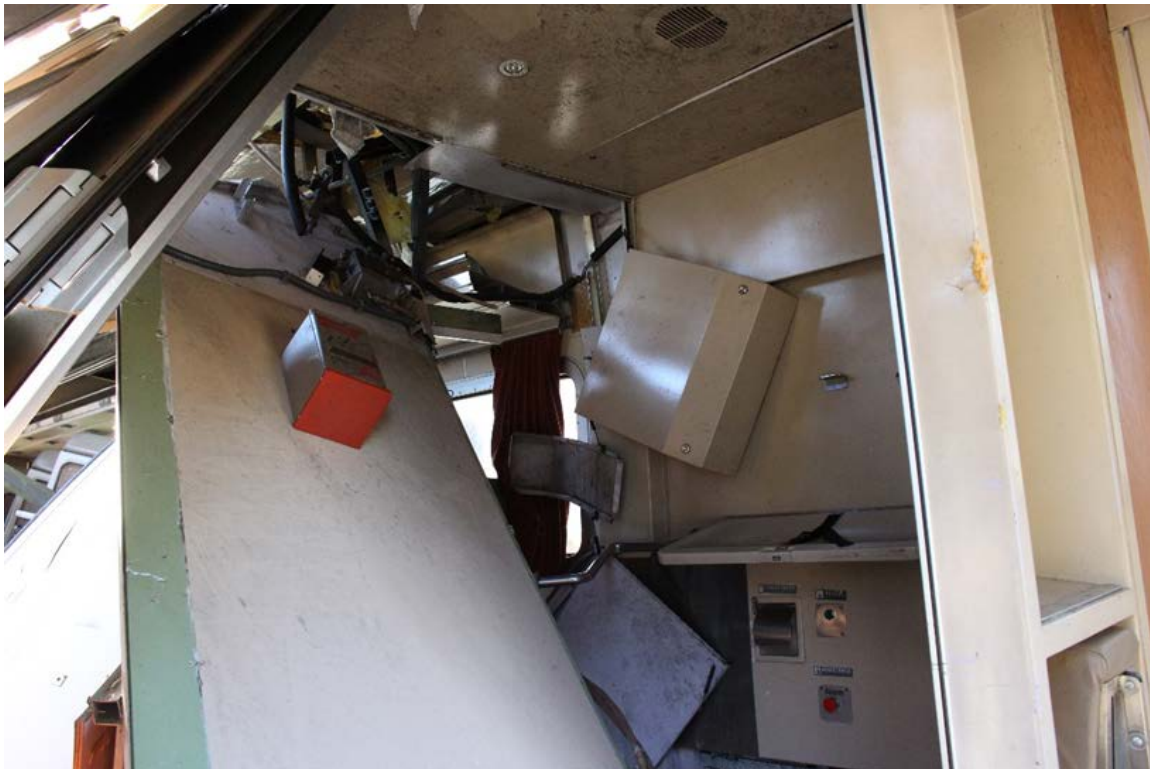
Figure 62. Photograph of the interior lavatory damage of AMTK 7504.

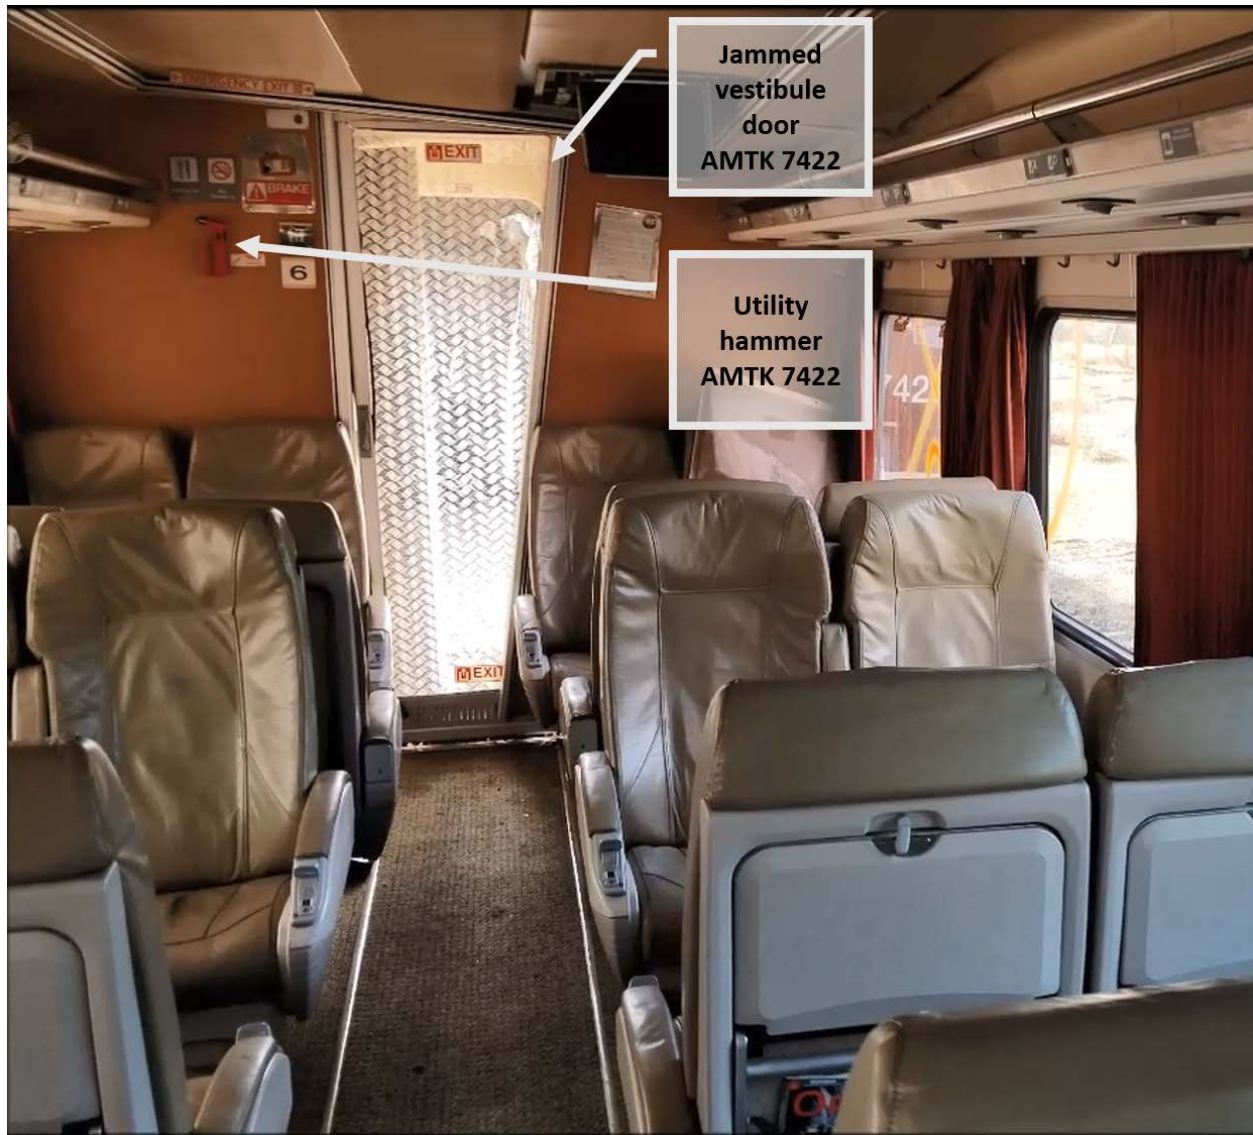
Figure 63. Jammed vestibule door, AMTK 7422.
